GARE DU NORD TGV & EUROSTAR

PARIS - FRANCE

Control of track movements at the Eurostar terminus during the repair of a sewer by grout injection

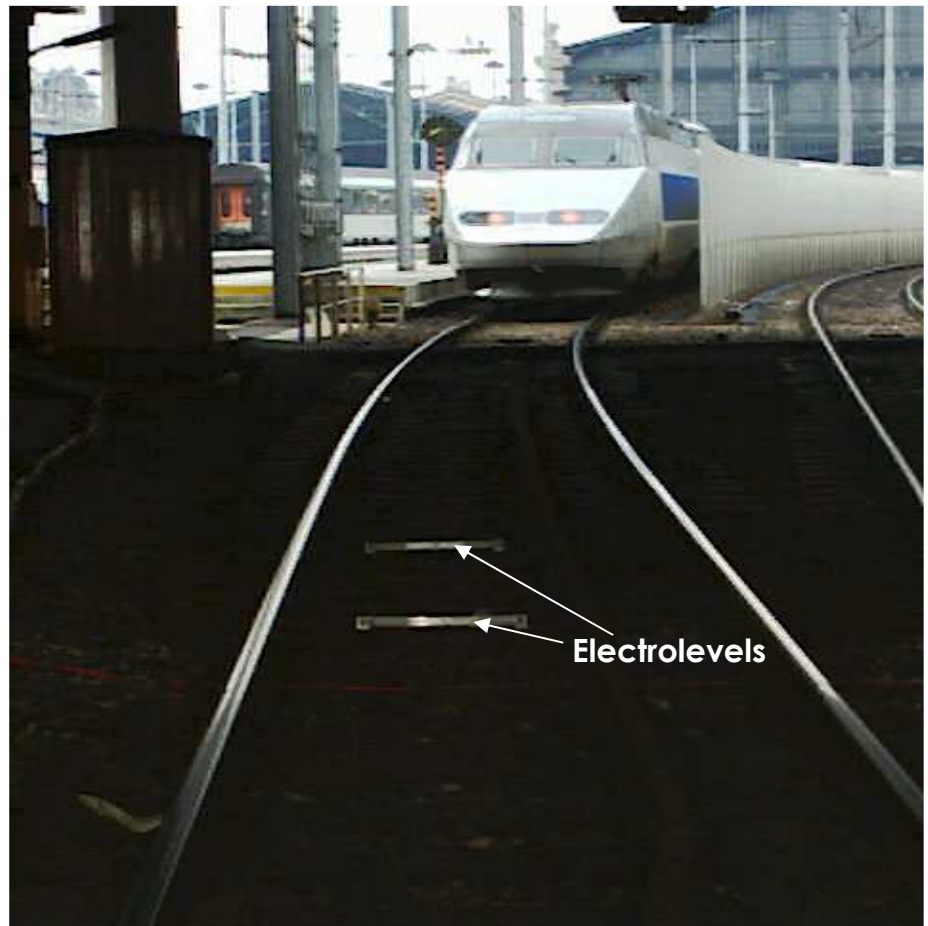
Gare du Nord Terminus: Electrolevels on TGV tracks

Fifty electrolevels were installed on the tracks.

The Geoscope software displayed the displacement from initial position, allowing precise control of the grouting works just beneath the tracks.
