Nab Scar

Lake District, Cumbria

Automated monitoring ensures structural stability to maintain Manchester water supply

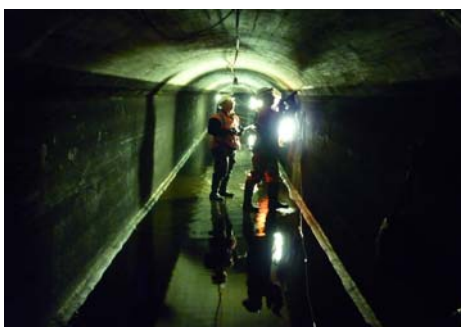
Installing within the conduit during the outage.

To determine vertical conduit deformations a 30m chain of horizontal In-Place Inclinometers (IPIs) were installed within the conduit. Due to the conduit being a carrier of drinking water, the IPI units were constructed from high grade stainless steel and the epoxy resin.

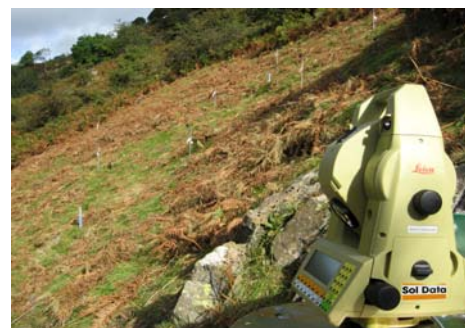
Cyclops providing real time slope displacements to the client

To provide surface monitoring characteristics along the slope, our CYCLOPS system was used. Incorporating 2 CYCLOPS working together, a 5m grid of monitoring prisms was positioned over the slope. The CYCLOPS units were fixed within the zone of influence and monitored their own position using reference prisms located on rock outcrops.
